IN THE
Supreme Court of the United States

No. **78-1216**

BRITISH AIRWAYS BOARD,

**PETITION FOR A WRIT OF CERTIORARI TO
THE UNITED STATES COURT OF APPEALS
FOR THE NINTH CIRCUIT**

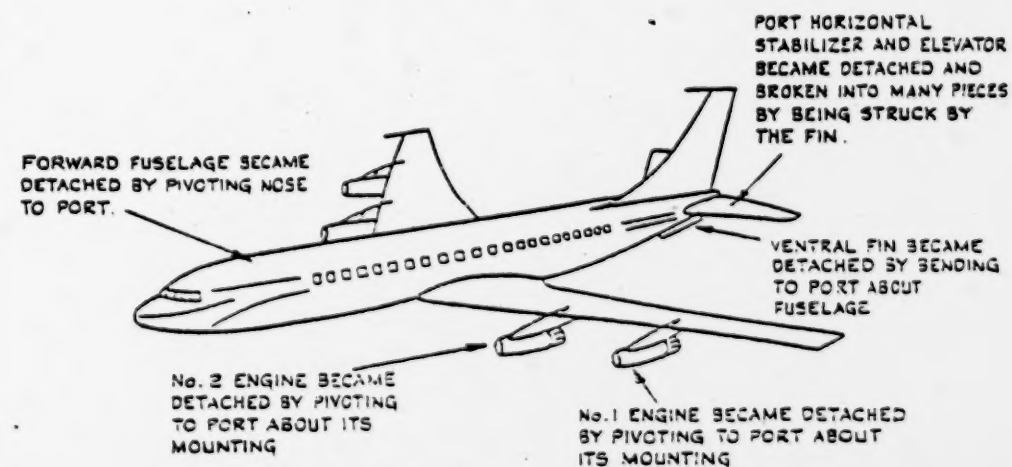
Fig. 10

In the case of G-APFE, very strong winds were blowing from just north of west at the time of the accident (Fig. 10) and a very long trail of wreckage (Fig. 3) resulted along the wind line. In addition to this a study of the planform of the distribution (Appendix C.2), showed that the aircraft was flying on a track across the wind, and to south of west. The analysis of the trajectory plots of the falling pieces (Fig. 11) together with the study of the planform (Fig. 12), suggests that the aircraft disintegrated at an altitude of about 5000 metres when it was about 7 kilometres to the south-east of Mt. Fuji.

found scattered after the accident to 707 G-APFE. Wind data is shown on Fig. 10, and trajectories on Fig. 11.

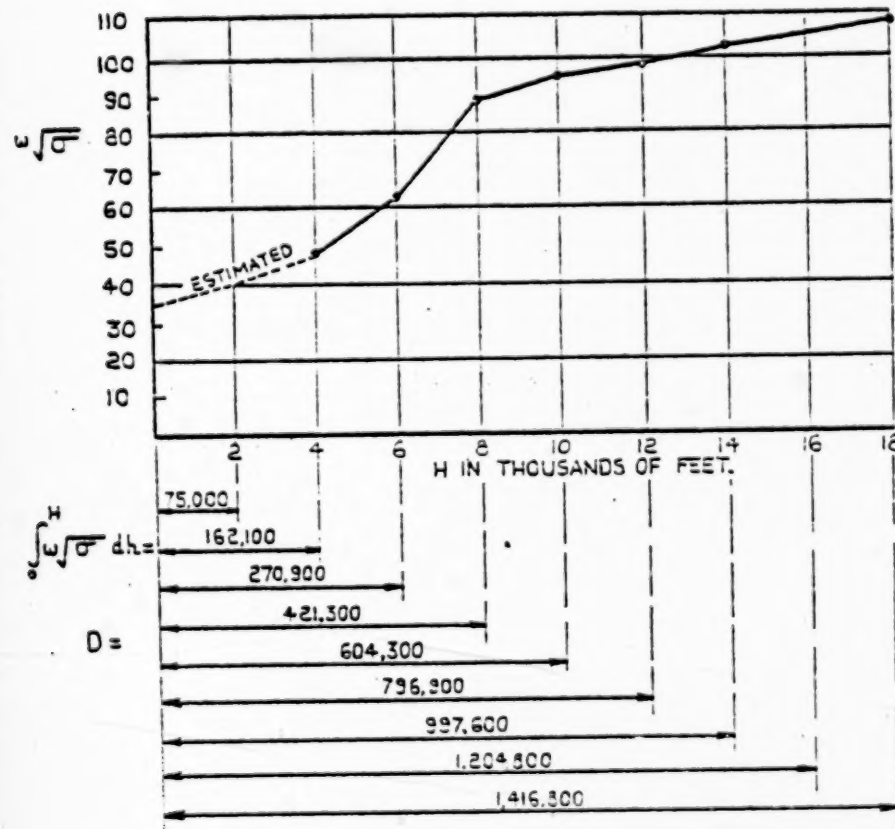
FIG. 11 WIND DRIFT TRAJECTORIES

on Fig. 11. However, a study of the planform of the wreckage distribution in the trail enabled the approximate track to be determined.

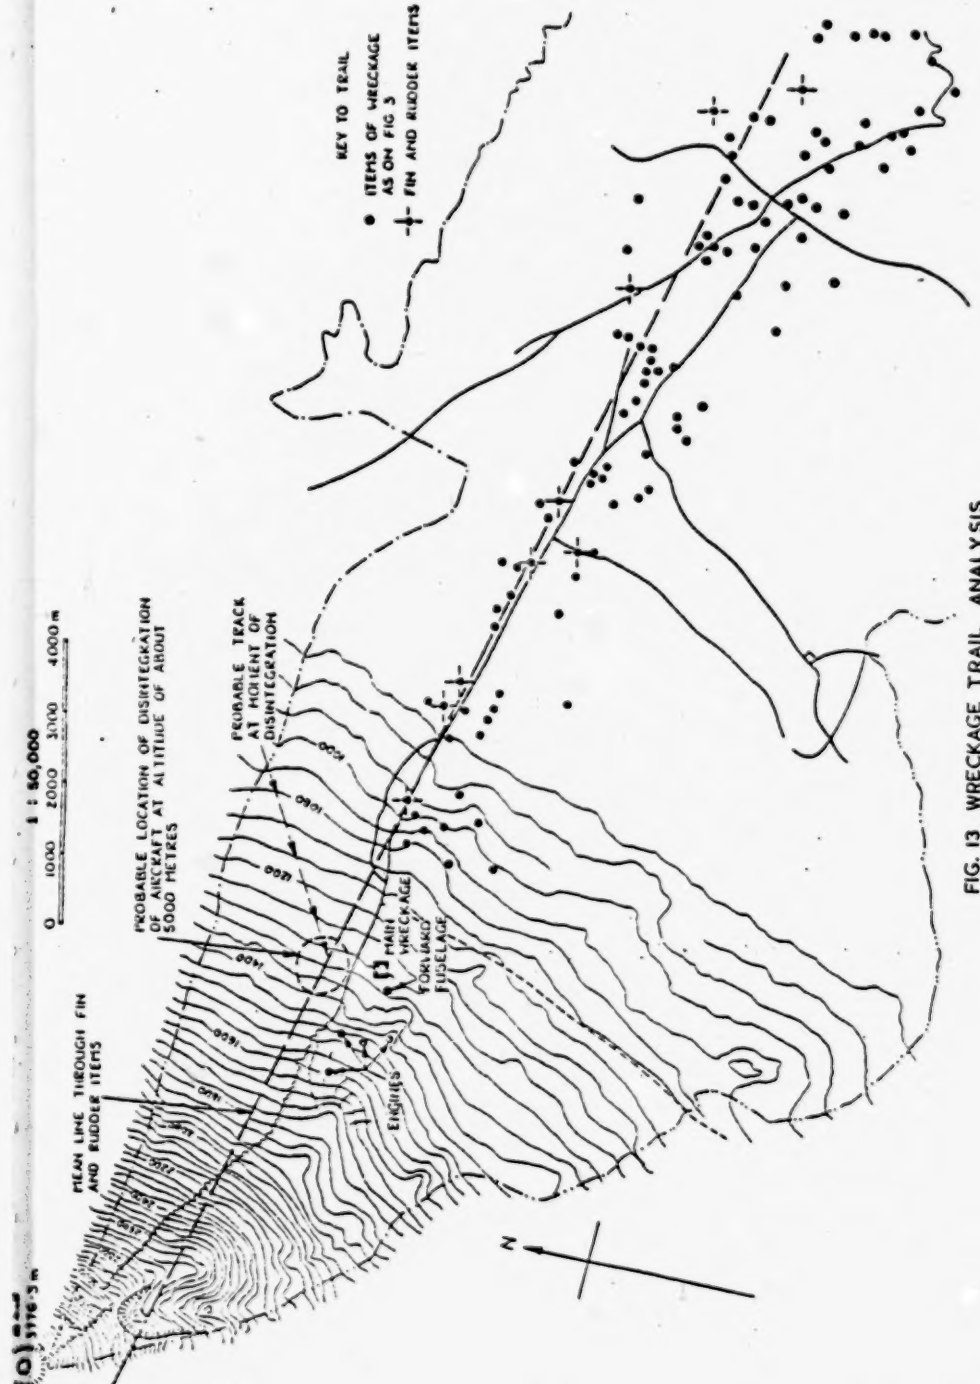
FIG. 13 WRECKAGE TRAIL ANALYSIS

(b) The aircraft was on a track to the south of west at the instant of disintegration and was approximately 7 kilometres to the south-east of Mt. Fuji (Fig. 13).

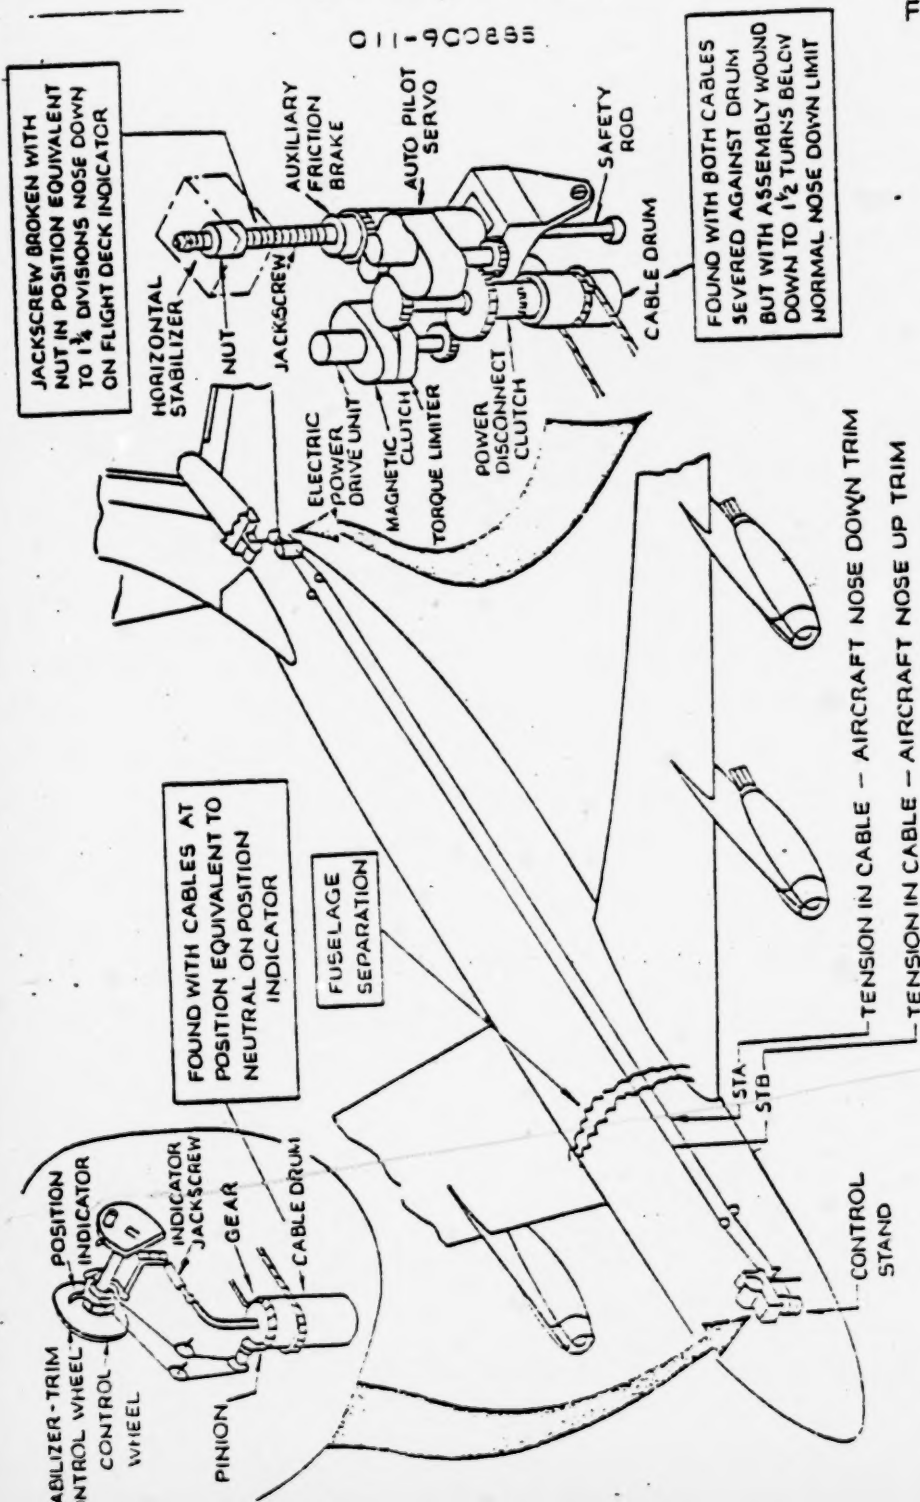
FIG.26 HORIZONTAL STABILIZER TRIM CONTROL SYSTEM

The trim system control drum, from beneath the flight deck floor, and parts of the rear actuating assembly, were available for examination. Details are given on Fig. 26 of

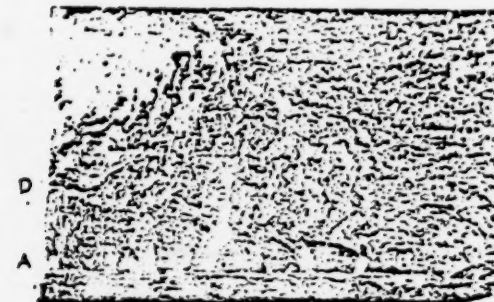
Fig.27&28

The fracture origin on one side of hole R1 is shown in monochrome in Fig. 27, and in colour in Fig. 28. The area indicated ABCD Fig. 27, exhibits features characteristic of fatigue fracture. In the fracture sequence the area of fatigue was followed by an area of plane strain fracture BCDE, and this in turn was followed by plane stress frac-

ture to complete rupture. The area of plane strain fracture can be clearly seen in Fig. 28, and is indicated A. It is apparent from Fig. 28 that corrosion of the fatigue areas of the fracture had occurred. Fig. 29 shows that fatigue cracks started at seven levels, at least, in the bore of hole R1. These are indicated A, B, C, D, E, F and G. Fig. 29 also shows considerable corrosion pitting of the bore of hole R1. Part of another fracture, Fig. 30 was also received. Failure had been initiated by fatigue fracture and multiple fatigue crack initiation was again apparent. The latter feature can be seen in Fig. 31, fatigue

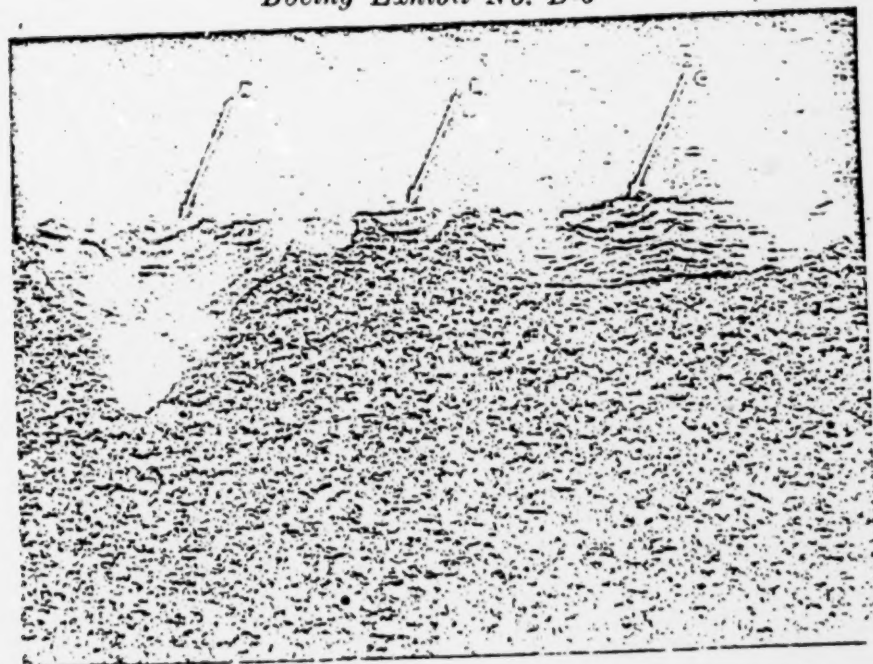
FIG.32

Metallographic examination of a cross section through hole R1 revealed considerable corrosion pitting. A typical example is shown in Fig. 32, with oxide filled pits indicated A, B and C. The metallographic section through hole R1 also revealed cracks whose surfaces had become oxidised. These are indicated A and B in Fig. 33, and are shown in greater detail in Figs. 34 and 35.

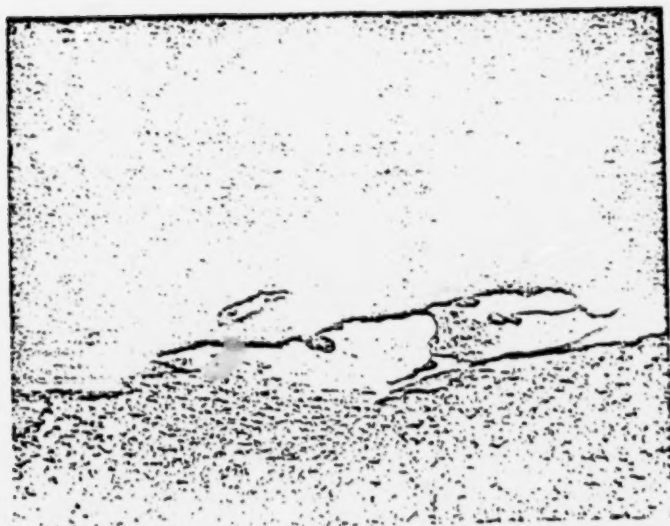
FIG.36

The Boeing report had noted a pocket of untempered martensite in the cross-section at the crack origin of hole R3. This is shown in Fig. 36. Microhardness measurements were made in this region and the hardness values at the positions indicated are given in Fig. 37. The figures confirm the suggestion that martensite is present in such regions. Other pockets of untempered martensite were observed in this cross-section and are shown in Fig. 38. Associated cracks are indicated A and B, Fig. 38, and are shown in greater detail in Fig. 39. A further pocket of

It seemed likely that the observed regions of untempered martensite had been produced during the drilling and facing of the holes, and as tensile test pieces that had been machined by The Boeing Company to check the tensile properties of the fitting were also received, these were examined. Surface machining marks on the shoulder of one of these test pieces are indicated A in Fig. 42. A transverse metallographic specimen prepared on material out from this area revealed regions of untempered martensite associated with these heavy machining marks. Typical examples are shown in Figs. 43, 44 and 45. The similarity between Fig. 36 and Fig. 45 is considered noteworthy.

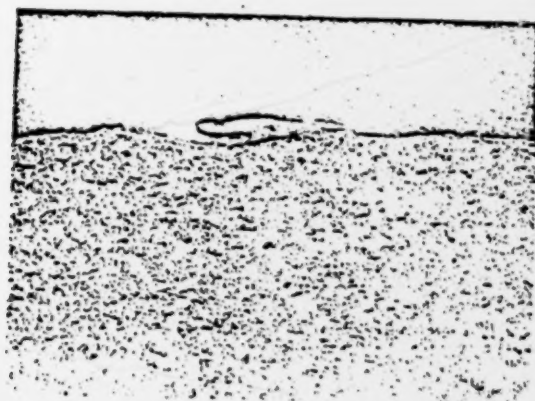
Fig.40&41

untempered martensite was observed on the facing of hole R1, and is shown in Figs. 40 and 41.
